Response of nonconforming RC shear walls with smooth bars under quasi-static cyclic loading

In this study, an experimental investigation is conducted to determine the behavior of RC shear walls found in old and existing buildings that do not comply with the design rules in modern earthquake standards. Scaled reinforced concrete shear wall specimens are built with smooth bars and low concrete quality. The dimensions of the shear wall specimens were selected with an aspect ratio bigger than two as 2500, 1050, and 150 mm for the height, length, and thickness, respectively. Four specimens are representative of nonconforming shear walls, and one wall is used as a reference specimen which was designed in accordance with recent building codes using deformed bars. The behavior of the shear walls is determined experimentally by displacement-lateral load relationship under lateral cyclic loading. The study used measurable parameters to investigate the behavior of the test specimens in terms of lateral force capacity, rigidity, ductility, dissipated energy, and displacement components contribution to the total lateral response of the walls. The results showed a substantial loss of stiffness,

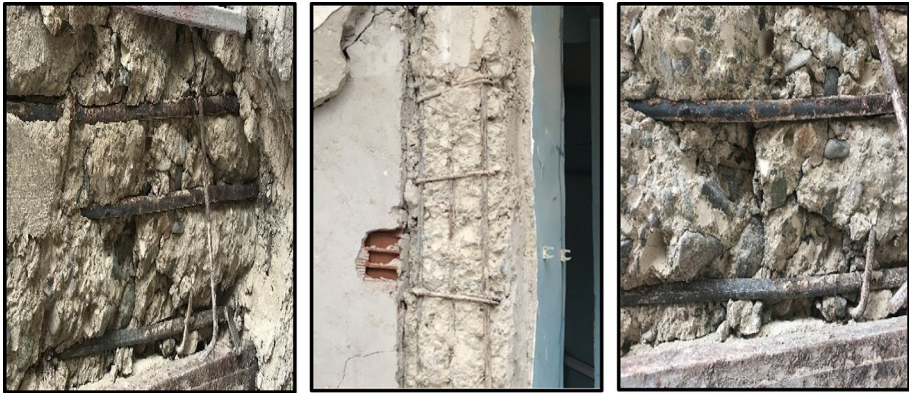
Fig. 1 Damaged RC columns in old buildings, smooth bar and low transverse reinforcement content (Caglar et al. 2022)

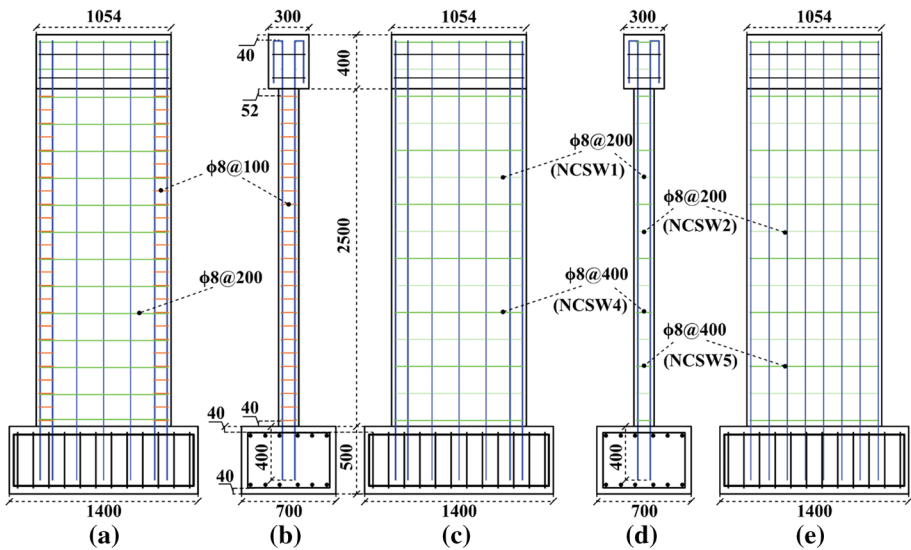
Fig. 3 Reinforcement details of the test specimens. Reference (CSW0) **a** front and **b** side sections, **c** NCSW1 and NCSW4 front sections **d** NCSW side section **e** NCSW2 and NCSW5 front section. Dimensions in (mm)

The details of the cross-section and the longitudinal and transverse steel configurations of the tested specimens are shown in Figs. 2 and 3, respectively. The reference test wall (CSW0) had a well confined columns in the boundary zone using 100 mm spaced ties, and transverse steel with 200 mm spacing. Two of the other nonconforming specimens (NCSW1 and NCSW4) used the same reinforcement configuration in the section as the reference wall, with concentrated boundary zone steel (CBZS) and the same bar diameters (12 mm for the boundary zone, and 8 mm in the web). The main difference was the use of smooth bars for longitudinal and transverse reinforcing steel, and the other was the absence of confinement ties. The remaining two nonconforming specimens (NCSW2 and NCSW5) used distributed longitudinal 8 mm smooth steel reinforcement bars. Two

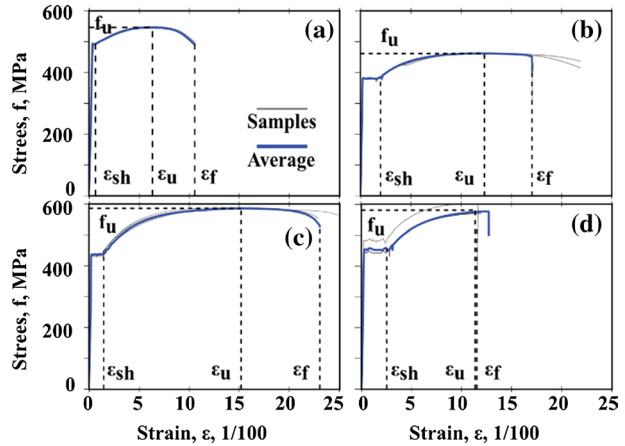
Fig. 4 Stress–strain relationships for steel bars used in the experiment, **a** 8 mm smooth, **b** 12 mm smooth, **c** 8 mm deformed and **d** 12 mm deformed reinforcement bars

Two types of reinforcement were used to build the test shear wall specimens, smooth and deformed steel bars. Also, for each type two diameter sizes, 8 and 12 mm, were used. Three 400 mm long samples of each kind of the reinforcement steel were tested to determine their average mechanical properties and presented in Table 2. The test performed according to ASTM E8/E8M-15a (2015) using a 50 mm strain gauge extensometer. Table 2 shows the yield (f_y) and maximum stress (f_u) and the corresponding strains ϵ_y and ϵ_u values, respectively. Also, the modulus of elasticity (E_s), hardening strain (ϵ_{sh}), and tangent modulus at onset of strain hardening (E_{sh}) are given in the table. The ultimate strain, ϵ_f , of the tested samples are calculated at the point where the stress value drops to 90 percent of the maximum stress (f_u). Stress–strain relationships for the four types of the tested steel bars are given in Fig. 4.

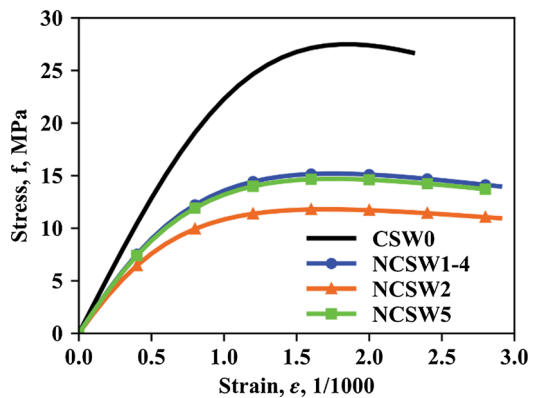
Fig. 5 Stress–strain relationships for the concrete used in the experiment

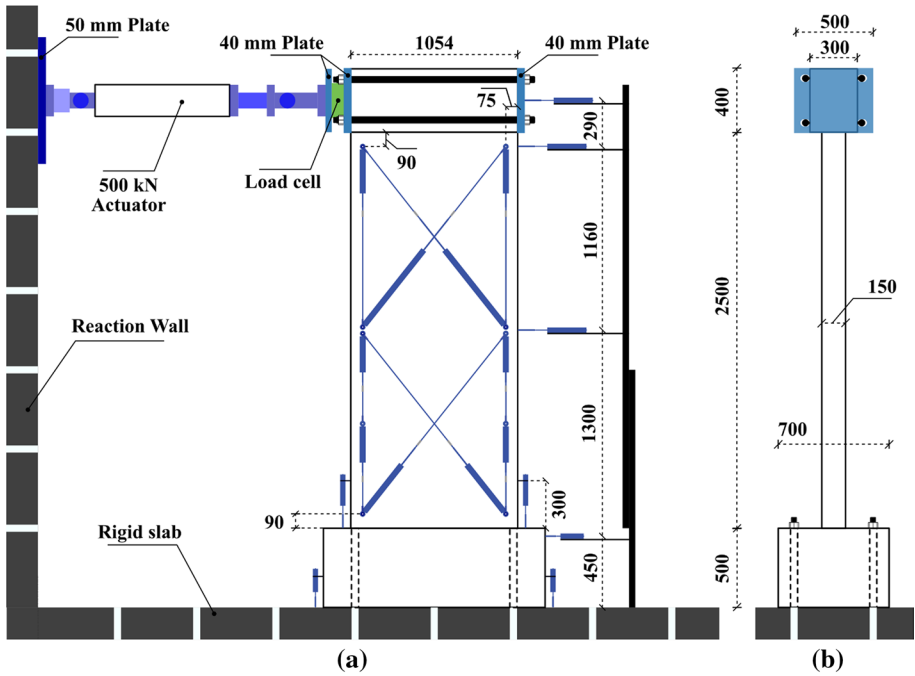
Fig. 6 Instrumentation setup used in the experiment, **a** front and **b** side views, **c** Linear potentiometer locations, **d** Out-of-plane support system and rolling wheels. Dimensions in (mm)

The responses of the tested shear walls under quasi-static cyclic loads were monitored using an array of linear potentiometer on the surface, and strain gauges fixed on the steel bars before casting the walls. A total of 18 linear potentiometer displacement transducers (LPDT) were used in the experimental setup to measure the global and local deformations. Three of them were used to measure the global lateral displacement of the tested specimen on three different levels, as seen in Fig. 6a. Four LPDTs placed in diagonal X shaped configuration over two levels were used to measure the shear displacements in the tested walls. Moreover, the flexure displacement was measured with the help of six potentiometers placed vertically along the height of the wall to measure the relative vertical deformation between the levels. Two more devices were placed on both sides of the wall and fixed at 300 mm height from the surface of the base, to measure the rotation of the wall at base level, mostly due to reinforcement bar slippage. Three other spring-return linear potentiometers were used to control the potential horizontal sliding and rotation of the concrete foundation of the wall.

In order to prevent any out-of-plane displacements that could affect the test results, a newly fabricated steel braced frame system was installed on both sides of the tested wall. Furthermore, the upper loading beam was supported through roller wheels contacting the surface of the beam to ensure the continuity of the lateral movement at the support point. Figure 6d shows the out-of-plane support system and the rolling support wheels.

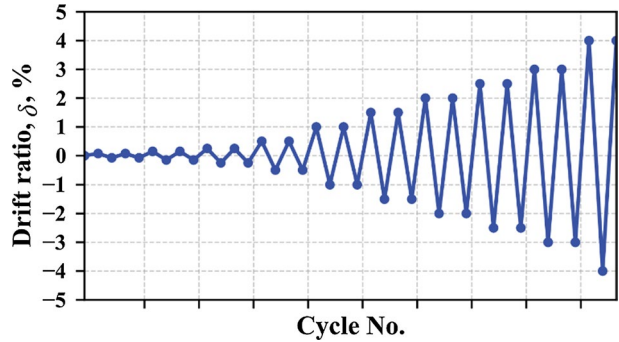
Fig. 7 Cyclic quasi-static load protocol

A displacement-controlled loading protocol was used in this experimental study based on the recommendation from ACI 374.2R (2013). Two cycles at each drift level were applied as shown in Fig. 7 with 0.075, 0.15, 0.25, 0.5, 1.0, 1.5, 2.0, 2.5, 3.0, and 4.0% drift ratios.

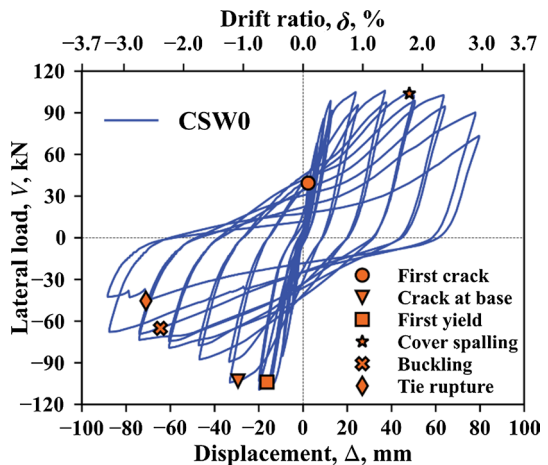
Fig. 8 Cyclic quasi-static response of the reference specimen

Fig. 8. In addition, crack patterns of the reference specimen at the end of the experiment are shown in Fig. 9. As seen in Fig. 8, the maximum load and the corresponding displacement values were measured as +105.93 kN and 37.00 mm (+1.37% drift ratio) when pulled in the positive direction, and +109.29 kN and +19.90 mm (+0.74% drift ratio) when pushed in negative direction, respectively. The first tensile crack was observed at a load of +39.44 kN and a corresponding displacement of +2.30 mm (+0.09%). First reinforcement yield was detected at a load of -103.90 kN and a corresponding displacement value of -16.30 mm (-0.60% drift ratio), this yield ($\epsilon_y = 0.0022$) was observed in the bar with a strain gauge labeled B1i (Fig. 13b). In succeeding stages and while the load increases, cracks started to form at different levels and the width and length of the previously formed cracks started to increase. The first crack formed at the base surface occurred at a displacement level of -29.40 mm (-1.09%) and a corresponding load value of -103.10 kN. When the applied displacement reached +48.05 mm (+1.78% drift ratio), the concrete cover started to break and spalling was observed. Consequently, within the same cycle in the opposite direction, bar buckling was first observed at -64.50 mm (-2.39%) displacement level. As seen from Fig. 8, the negative side showed a faster degradation compared to the positive side. This was the result of local damage (cracks, concrete spalling and bar buckling) was firstly observed and developed significantly afterwards at this side of the wall (Fig. 9). Moreover, due to the increase of confinement force with higher drift ratios, the

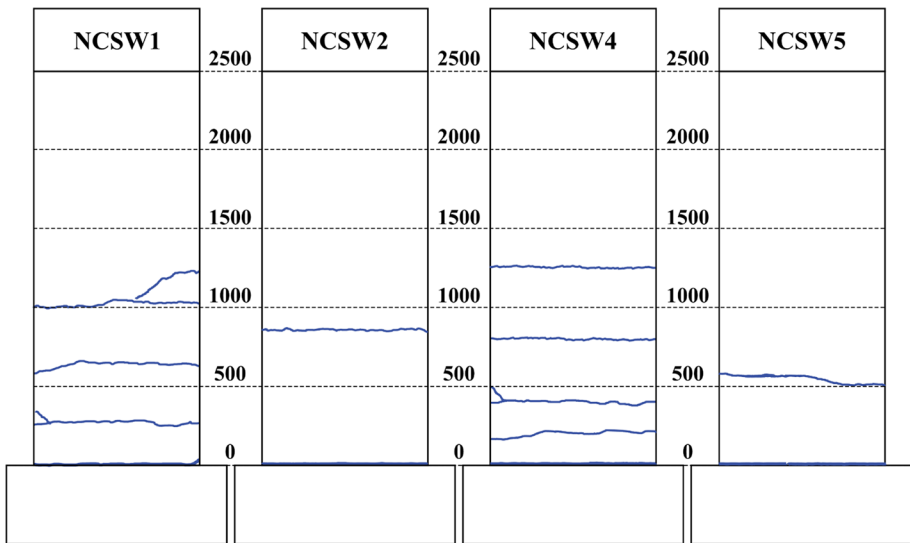
Fig. 11 Crack patterns of the nonconforming shear walls at the end of the experiment. Dimensions in (mm)

Table 4 summarizes the main failure events occurred during the test for the walls with their drift ratios. Moreover, crack patterns of all the NCSW specimens at the end of the experiment are shown in Fig. 11. Also, Fig. 12 shows an example of the big crack that formed at the base level in all the nonconforming shear walls. As seen from the figures, very few cracks have occurred during the experiment (3 to 4 for the shear walls with CBZS, and only one for the specimens with distributed reinforcement). All the

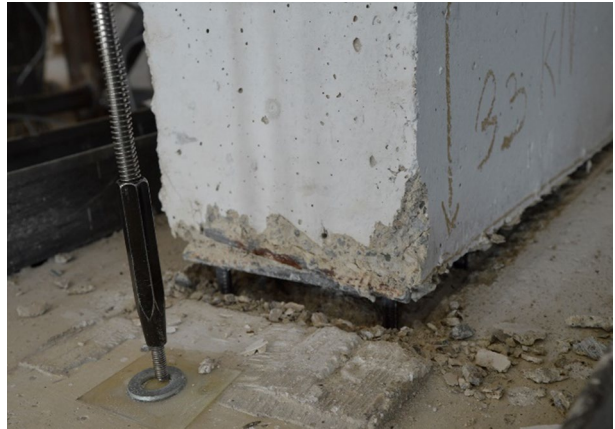
Fig. 12 Crack at base level in specimen NCSW2

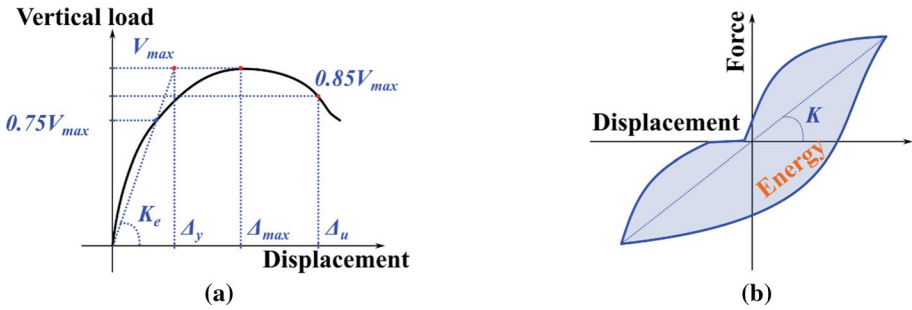
Fig. 14 **a** Definition of effective stiffness and main drifts figures on the lateral load–displacement envelope, **b** dissipated energy and stiffness calculation for one loop

According to the definitions from Fig. 14a, V_{max} and Δ_{max} are the maximum lateral force capacity of the shear wall specimen and the corresponding displacement, respectively. The ultimate drift capacity, Δ_u , is adopted to be the displacement reached before

losing 15% of the maximum strength (Murty et al. 2012; Zhang et al. 2014). The effective stiffness of the element, K_e , is calculated according to ACI 374.2R (2013), where it is acknowledged as the slope of the line between the origin and 75% of the maximum strength (Fig. 14a). Moreover, the yield displacement, Δ_y , is determined as the projection of the intersection point of the line starting from origin with K_e slope and the horizontal line at V_{max} level. Additionally, the cumulative dissipated energy, E_h , of the specimens is calculated as the sum of the areas defined by each of the loop curves of the lateral load–displacement relationship as seen from Fig. 14b.

To take into account both of the positive and negative direction in the evaluation study, the ductility, μ , and the element stiffness, K , are calculated as per Eqs. (1) and (2), respectively (Razvi and Saatcioglu 1994). This method is also used to determine the stiffness degradation of the wall specimen under quasi-static cyclic loads. The average secant stiffness of each loop is calculated using Eq. (2) and by considering the positive and negative peak points of the loop, as seen in Fig. 14b.

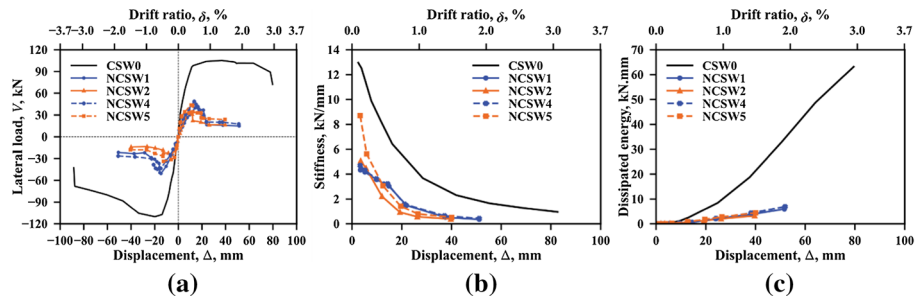
Fig. 15 Comparison of **a** response envelope, **b** stiffness degradation, and **c** energy dissipation

Envelops of the lateral load–displacement relationship for all the specimens are presented in Fig. 15a. Comparing the curves of the nonconforming shear walls (NCSW) with the reference shows that the adhesion between the smooth reinforcement bars and the concrete was lost rapidly and the bars started to slip from the concrete base before

Stiffness degradation is compared for all the test walls in Fig. 15b. The greatest effective stiffness was obtained for the reference specimen (CSW0) due to the high strength of concrete and the contribution of the deformed bars. In addition, the test specimens built with distributed reinforcement (NCSW2 and NCSW5) showed a relatively high initial stiffness, since only one crack was formed and behaved similar to non-cracked sections. After the formation of the big crack at base surface the stiffness decreased rapidly compared to the walls with concerted boundary zone steel.

The energy dissipation capacities of NCSW specimens, that experienced slippage of the longitudinal reinforcements before reaching the yield limit, are substantially at lower levels than the reference shear wall (CSW0). The cumulative energy dissipation of the tested specimens is given in Fig. 15c. The figure shows that the dissipated energy of the reference shear wall reaches 60 times the energy dissipated by the nonconforming specimens when compared at the ultimate displacement level. Additionally, when the NCSW specimens are compared against each other, it is seen again that the energy dissipation is higher in the shear walls with concentrated boundary zone steel.

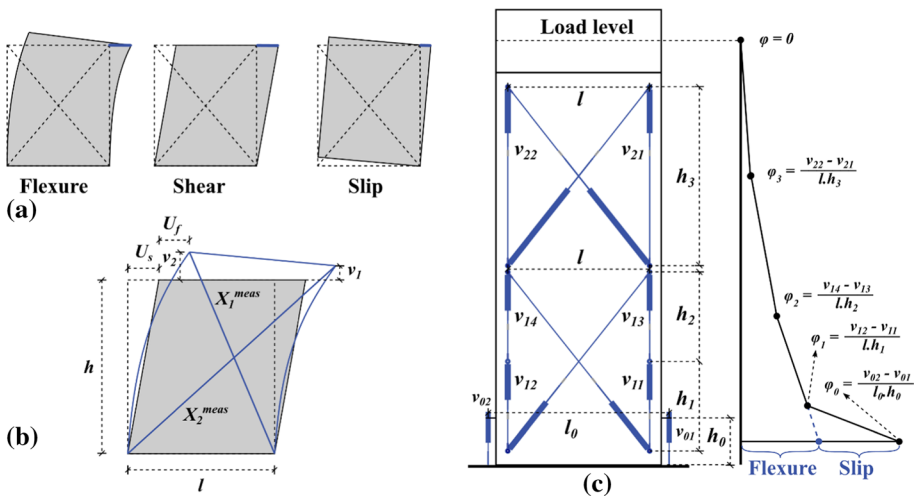
Fig. 16 a Three displacement components model and deformation calculations for b shear, flexure, and c bar slip displacements

The tested nonconforming shear walls showed a significant contribution of bar slip to the total lateral load displacement. To properly investigate this phenomenon, the total displacement should be broken down into its main ingredients. Three-component approach was adapted in this study, where the total deformation of the wall can be described as the sum of three different parts, flexure, shear, and bar slip displacements (Fig. 16a).

The contribution of the bar slippage to the total lateral displacement of the tested specimen was obtained using the methodology described by Sezen and Moehle (2006). Figure 16c shows the estimated curvature distribution along the element, where the average curvature at each level is determined as:

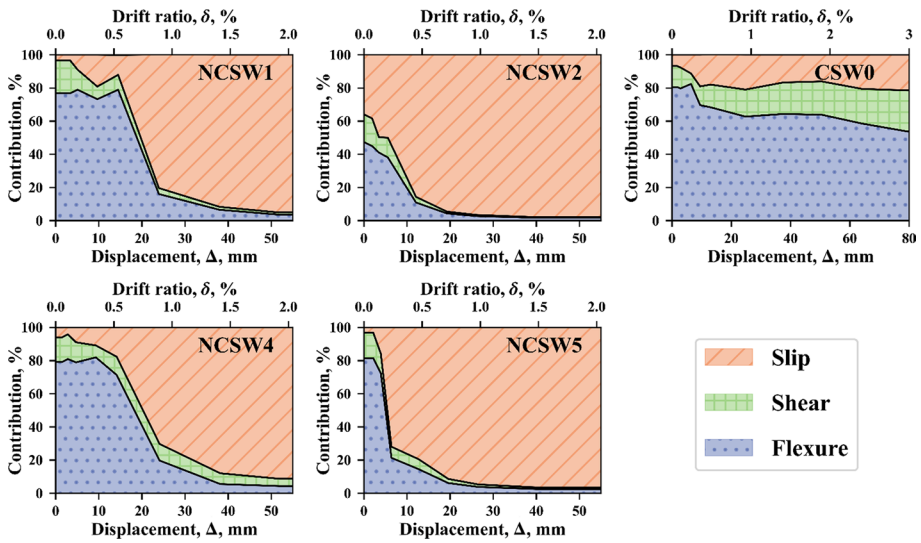
Fig. 17 Displacement components contribution to the total lateral displacement

From the figure, it is clear that the governing displacement component for the non-conforming shear walls is the part which formed from the bar slip phenomena. This component is usually noticeable, for all the NCSW specimens, after creating the big crack at the base surface, and a significant drop of strength is observed after reaching the maximum lateral force (Fig. 10). For instance, the flexural part of the displacement for NCSW1 is about 79% when V_{max} is reached and crack-at-base is formed, and drops to 16% at the next drift level, while the slip component increases from 8 to 80% for the same drift ratios. In a same manner, slip-displacement rises 36, 51, and 56% after crack-at-base formation for the specimens NCSW2, NCSW4, and NCSW5, respectively. And after this stage, the slip-displacement component contributes about 97% to the total deformation. In addition, the test specimens with CBZS showed a slightly more flexural behavior than the walls with distributed reinforcement. All the nonconforming shear walls exhibited a minimal shear behavior, and the shear-displacement contribution was very small compared to the other two parts.

On the other hand, the reference shear wall sustained a notable flexural behavior throughout all the experiment stages and formed a pronounced plastic hinge, with non-negligible shear and slip contribution to the total lateral deformation. The flexural displacement at V_{max} is 68.3%, while the shear and slip parts are 13.7 and 18.1%, respectively. Although, the CSW0 exhibited a crack formation at the base level, the flexural displacement contribution to the total deformation is dropped only 15.2%, and the slip part increased 11.3%. The displacement components contributions at the end of the test are 37.6, 31.1, and 31.4% for the flexure, shear, and slip displacements, respectively.
